Survey  
of  
public rights of way (path)  
in  
South Milford Parish

Report to the South Milford Parish Council

Date: 16<sup>th</sup> February 2021

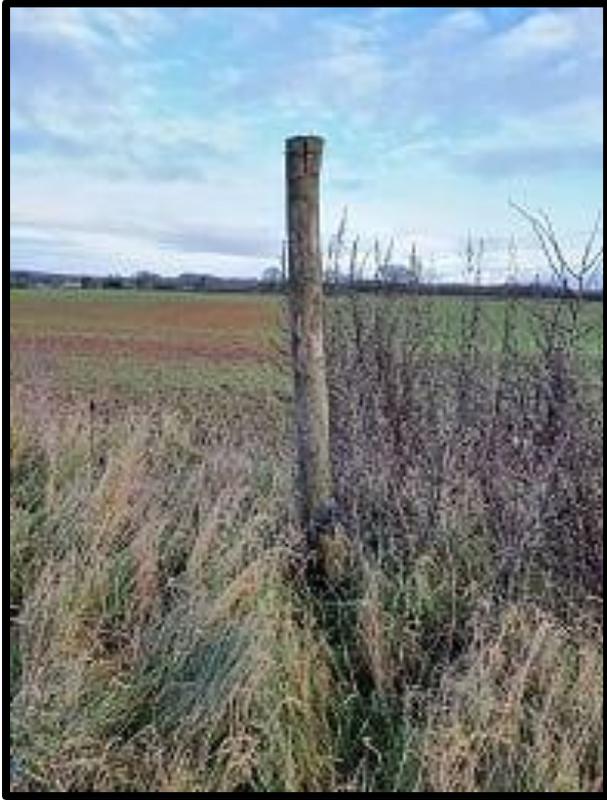
- Surveyed on 17/11/2020 by HGS and on 01/01/2021 by RdFD and IdFD.
- There are no signposts on either end of the path.
- The path is obstructed at the Long Heads Lane end by a hedgerow and a wall; hence it is not possible to cross to Long Heads Lane. However, Long Heads Lane is to an official public right of way.
- This path was subject to a Joint Statement by South Milford Parish Council and Monk Fryston Parish Council in December 2020.

*Figure 3: Photo of path 35.59/14/1 A162 bypass end showing that there is no signage*

- As per the Joint Statement by South Milford Parish Council and Monk Fryston Parish Council, the Councils asked that the path was reinstated and signposted, acknowledging the landowners' right to apply for a diversion order.

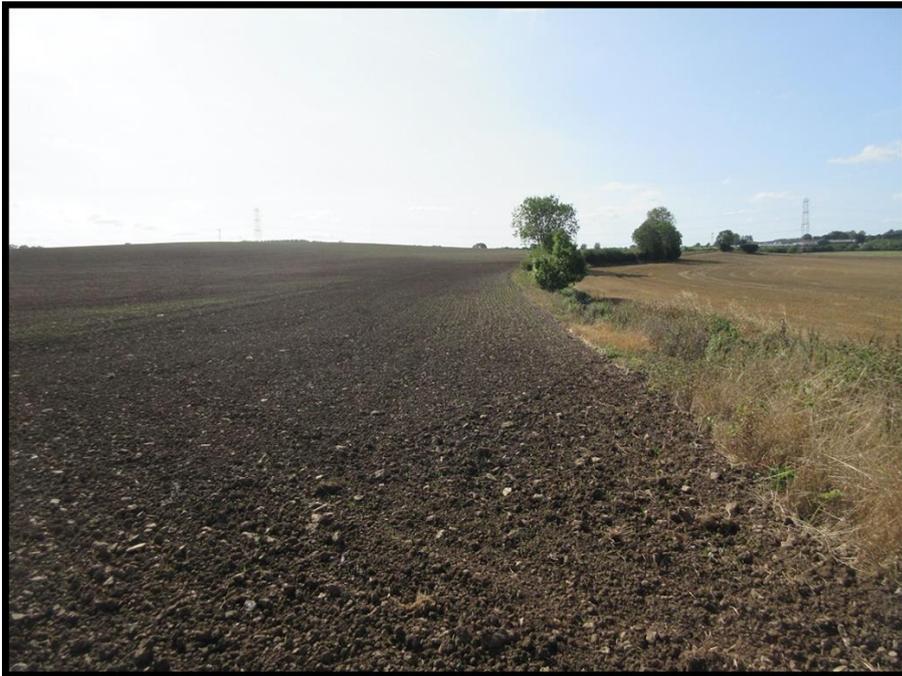
- Surveyed on 19/09/2020 by TJ.
- Starting from Westfield Lane.
- There is no path sign at the roadside. There is a barrier across the farm track where the path commences but it is possible to walk around the barrier.

- The track bears south for approx. 200 m. The path should then head west along the border between 2 fields. Both fields have been cultivated to the edge - there is no discernible path.

Figure 5: Photo of path 35.59/10/1 at the Westfield Lane end showing no footpath across the fields

- This path is not usable and has not been since the construction of the A1M, unless a footbridge or underpass is constructed across the motorway it will remain unusable. If it is not feasible for a method of crossing the A(1)M to be built, our suggested action is for NYCC promote an extinguishment order.

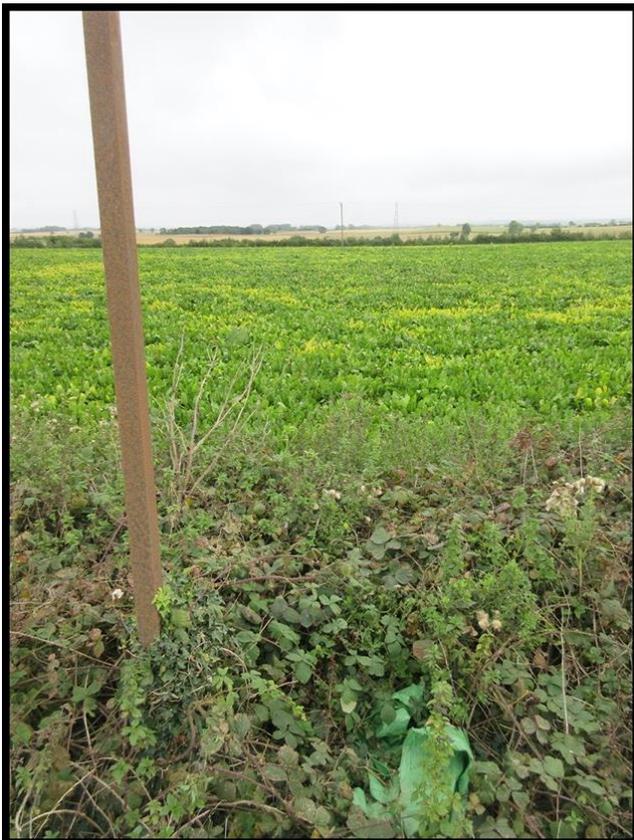
- I walked for 400 m along the field edge, the path should then cross a field but there is no pathway visible. At this point, it is possible to see the motorway, which runs in a cutting below the level of the field.

Figure 6: Photo of path 35.59/10/1 showing no footpath across the fields

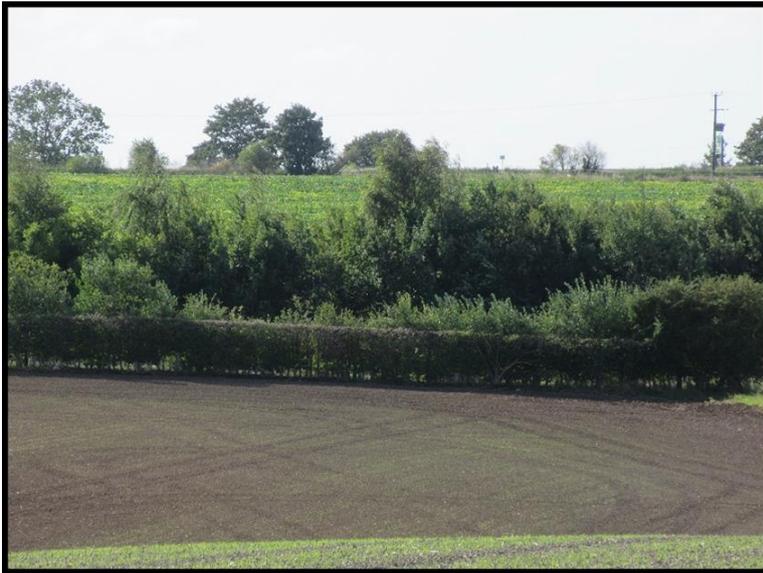
Figure 7: Photo of path 35.59/10/1 showing no footpath across the fields

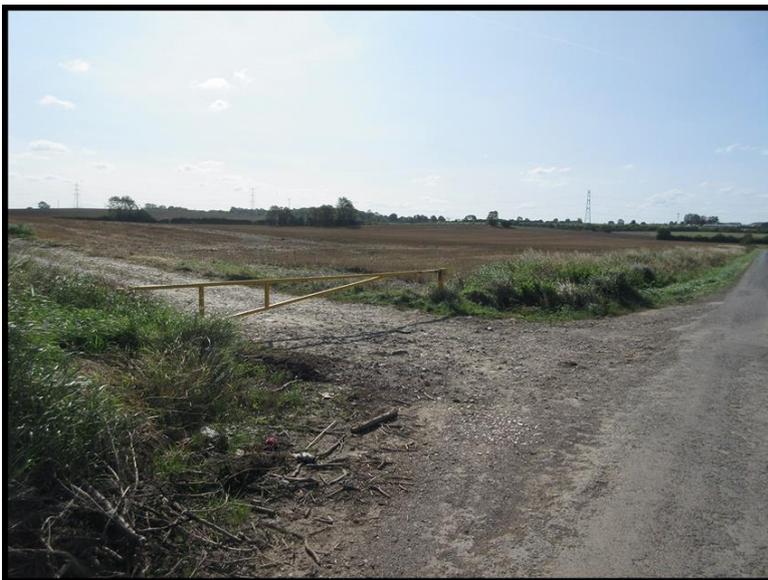
- From the A63 southbound there is a signpost for the footpath in the vicinity of the lay-by. The route of the path would involve scrambling down and overgrown banking and the crossing a farmers field, there is no pathway visible and at the far side of the field there is the motorway.

Figure 8: Photo of path 35.59/10/1 at the A63 end

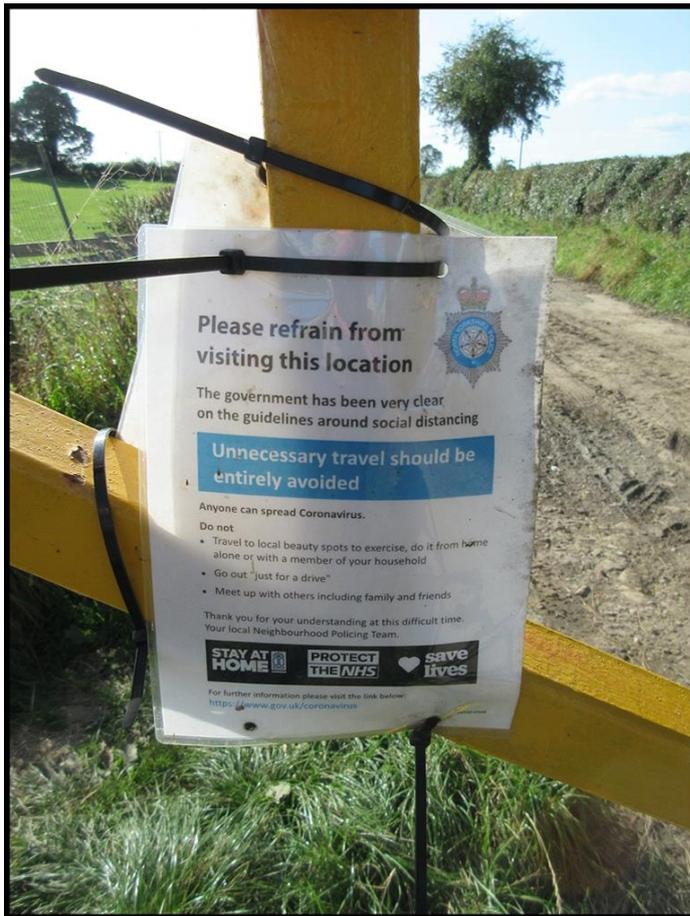
- At the Eastern (Lumby) end there is a step over barrier across the farm track, it is possible to walk over and round the barrier.
- At the time of the survey, there was a NY Police notice on the barrier asking people not to visit this location due to COVID restrictions, although this no longer relates to the regulations operating at that time.

Figure 10: Photo of the NY Policy sign on path 35.59/13/1

- To install a signpost at the A1246 end.
- To remove the sign asking people not to visit the location.

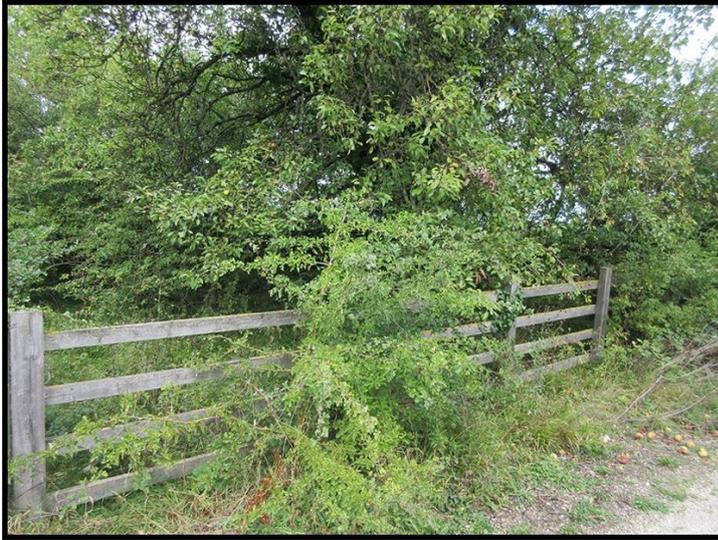
- Surveyed on 20/09/2020 by TJ.
- There is no access to the path at the A63 end: there is an old fence with no gaps, the path itself is blocked by undergrowth. It is possible to imagine where the path once existed as there is a slightly less overgrown clearing of about 1.5 metres extending along the course of the path, however there is no access to the path at either end, both being blocked by fencing and undergrowth.
- There is a field access approximately one third of the way along the path. At this point also the access is blocked by fencing and undergrowth – this area has been subject to fly tipping.
- This path does not appear to have been accessible for many years and it is not possible to use it in its current state.
- Photos show A63 end and Milford Hotel end.

Figure 12: Photo of path 35.59/17/1 at the A63 end

- This path does not exist as a usable path, as there is no access to the path and it would require extensive clearing of undergrowth and fencing at the access points and along the way to make it usable.
- As the roadway which runs alongside the path from the A63 to the back of the hotel is currently used as an alternative, we suggest that NYCC works with landowners to diver the path onto the roadway and install signposts.

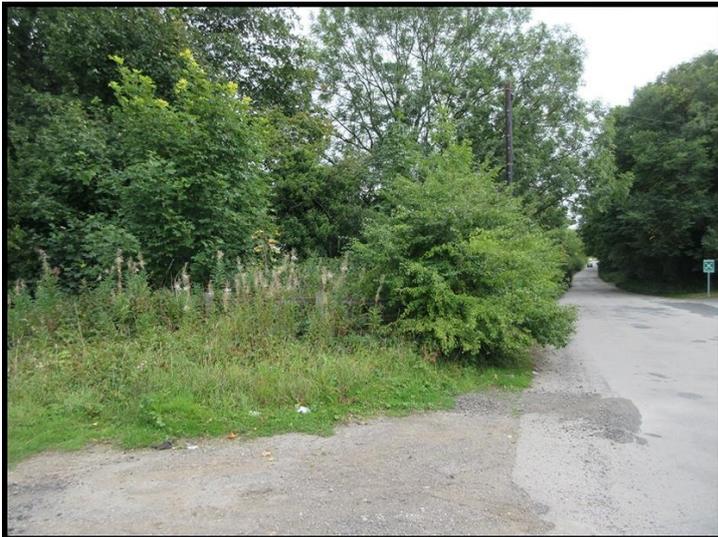
Figure 13: Photo of path 35.59/17/1 at the Milford Hotel end

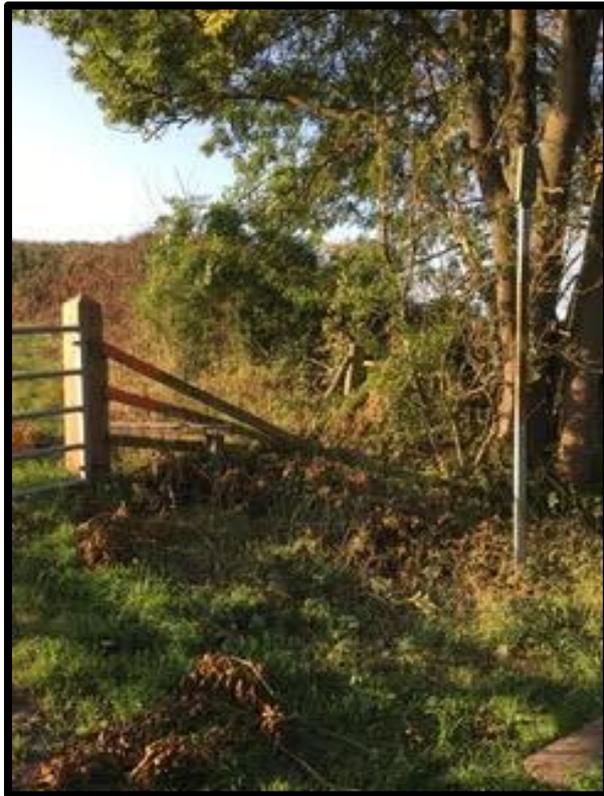
*Figure 16: Photo of way through fence at point F (Whin Lane) of path 35.59/9/1*

- The way through the fence at point F (Whin Lane) requires maintenance as per photo.
- To help walkers, we suggest a new signpost after the first signpost at the south end.

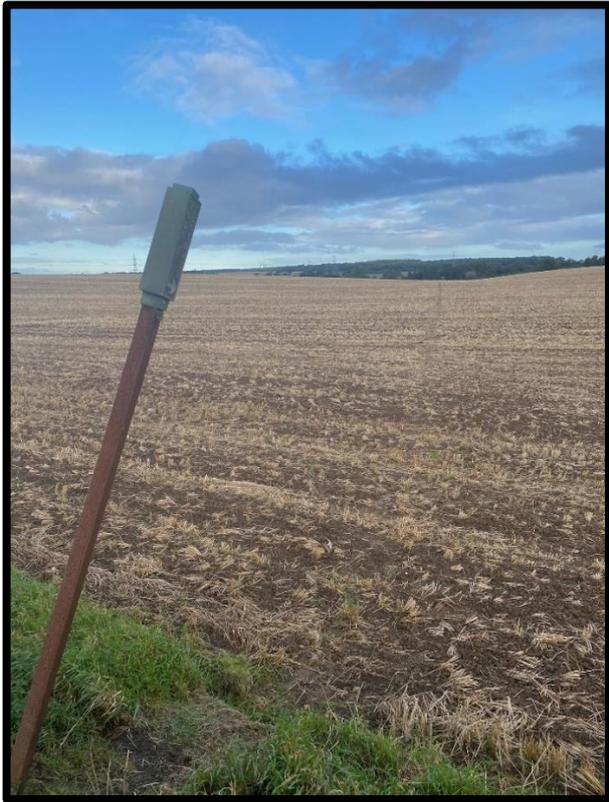
Figure 20: Photo of 35.59/12/1 southern end

- Secure signpost at the southern end.
- Install signpost at the gate.
- Repair steps.
- Correct the location of the signpost at the northern end.

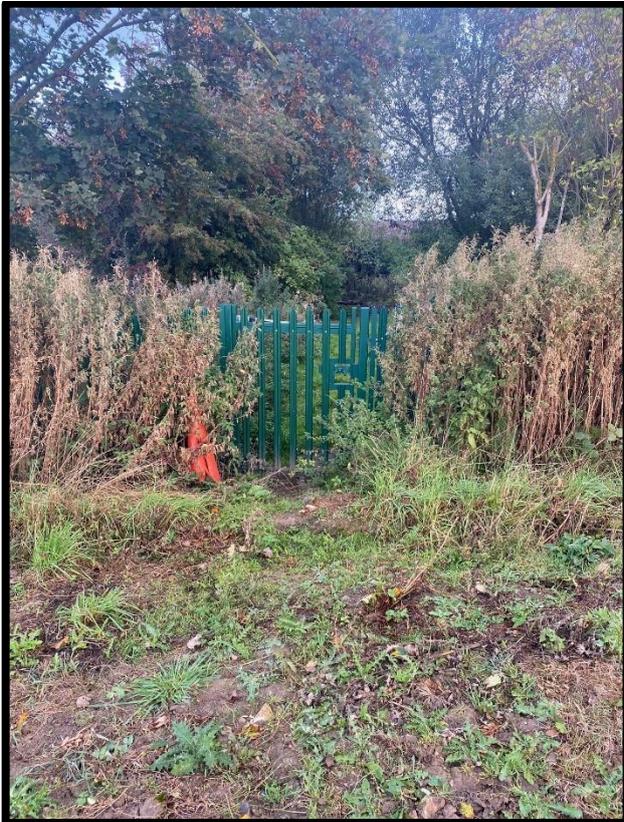
Figure 21: Photo of 35.59/12/1 gate to crossing

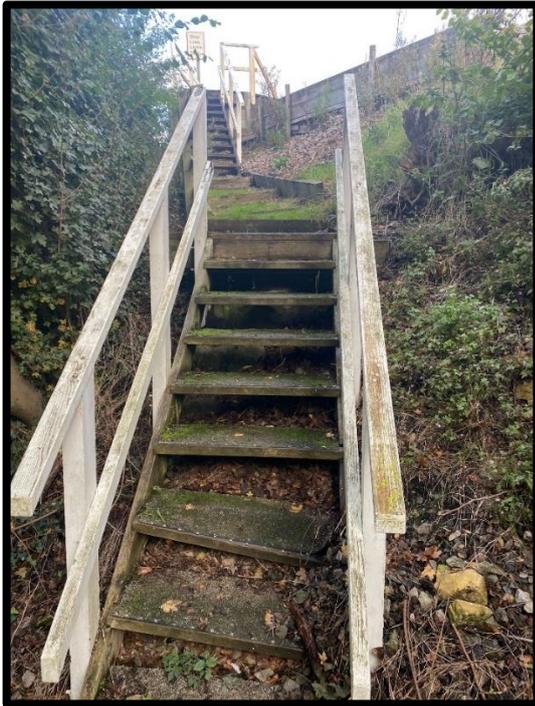
Figure 22: Photo of 35.59/12/1 steps

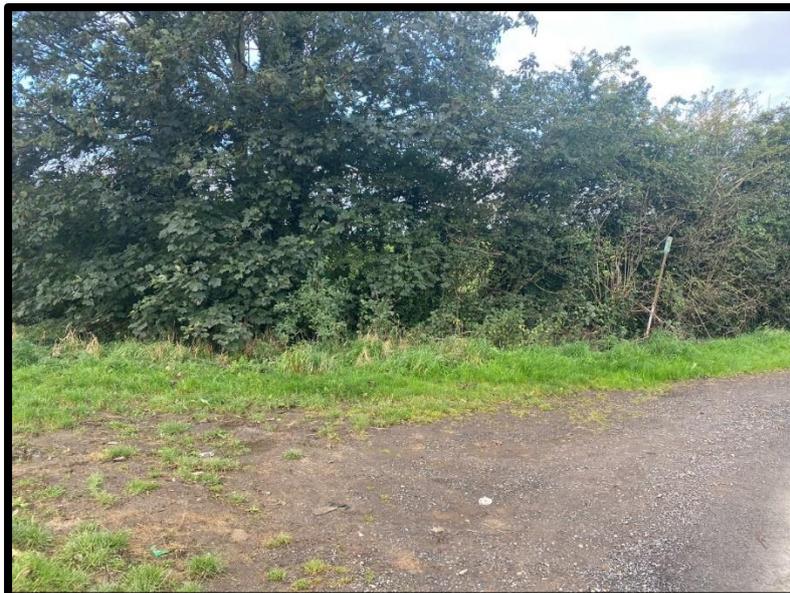
Figure 23: Photo of 35.59/12/1 northern end

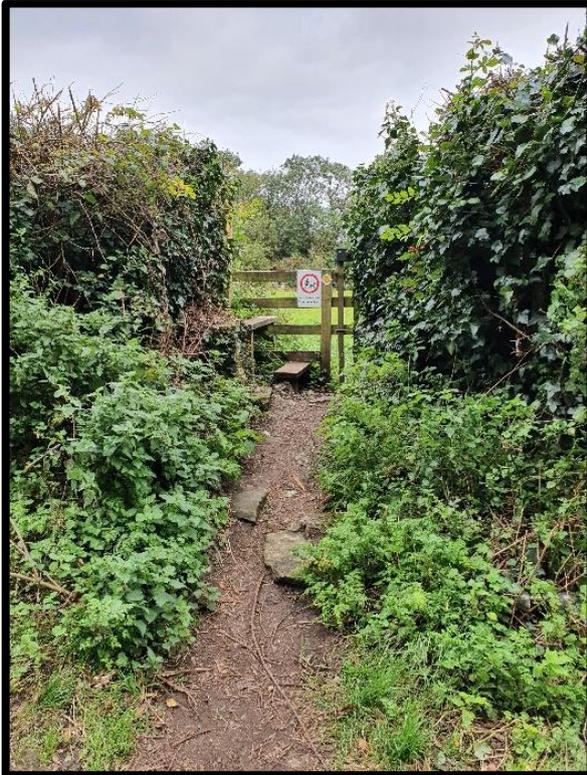
- Surveyed on 26/09/2020 by RdFD and IdFD.
- From Well Lane, there is no signpost marking the path although there is a stile.
- The path across the field boundary is signposted with a yellow arrow and there is a stile.

Figure 25: Photo of 35.59/11/1 Well Lane end: no signpost

- Install signposts.
- To install traffic lights on the railway crossing, given that it is heavily used by young people to and from Sherburn High School.
- Confirm the path route by the former Mill Farm Nursery.
- Repair the handrails in footbridge.

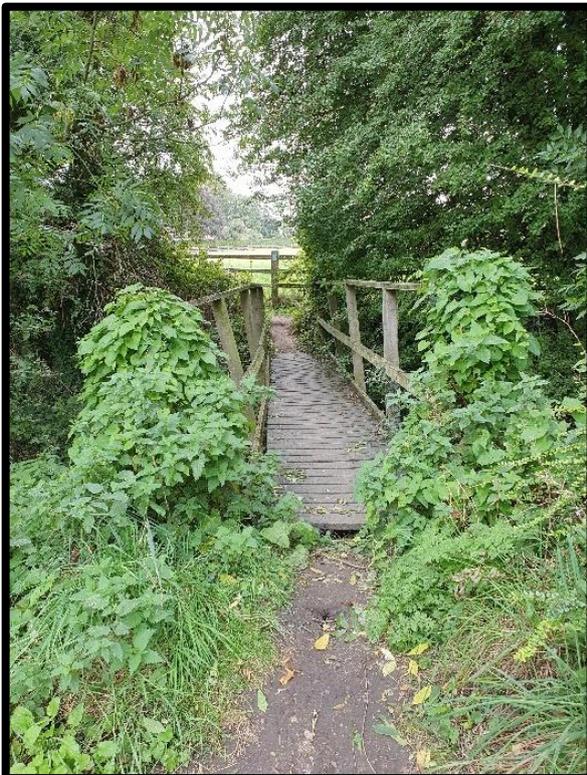
- There is a foot bridge across the stream – passable but handrails are in poor condition.
- According to the Definitive Map, the path crosses private dwellings, marked on the map as Mill Farm Nursery. Given that it is not possible to take the definitive line, I walked on what seems to be the private dwelling's driveway to Mill Lane (unimpeded).

Figure 26: Photo of 35.59/11/1 Well Lane end: bridge is in poor condition

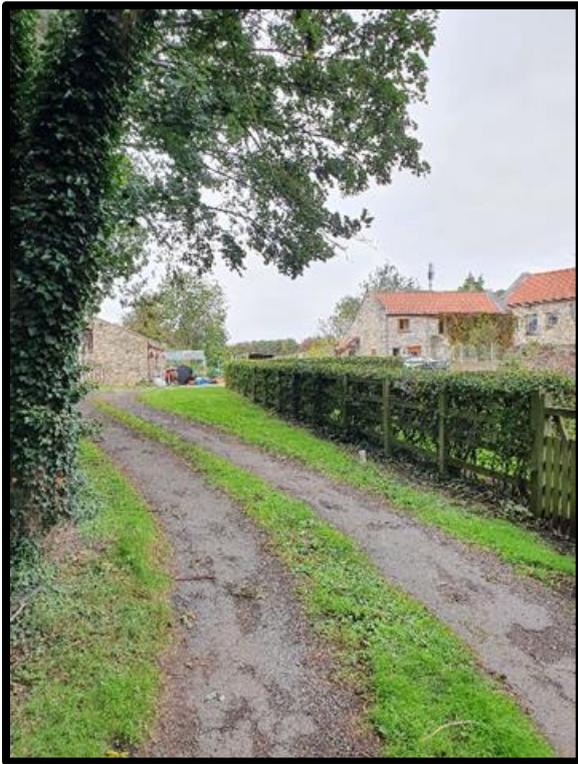
Figure 27: Photo of 35.59/11/1 showing private dwellings in the definitive line of the path

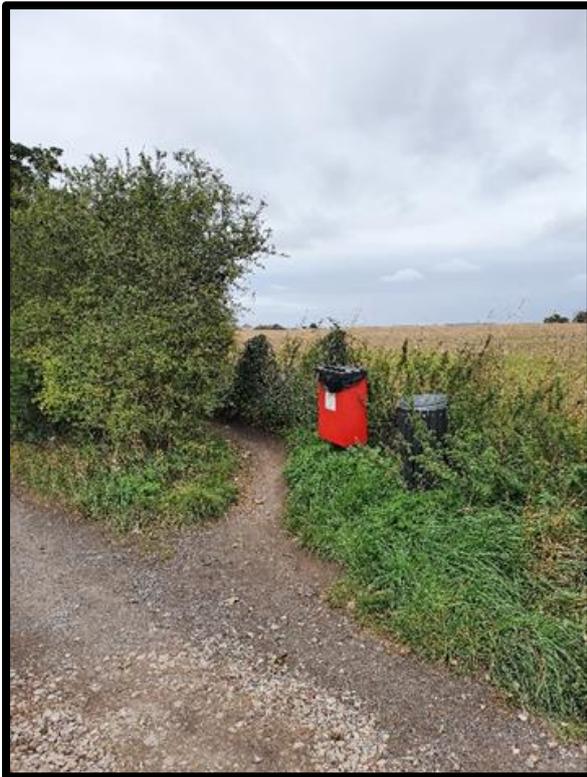
- The path crosses Mill Lane into a field. The path is clear of vegetation but there is no signpost.
- The railway crossing is fenced and signposted. Visibility is poor due to a bend and there are no traffic lights. There are no signposts indicating that the path is a public right of way.

Figure 29: Photo of 35.59/11/1 no signpost on the crossing over Mill Lane

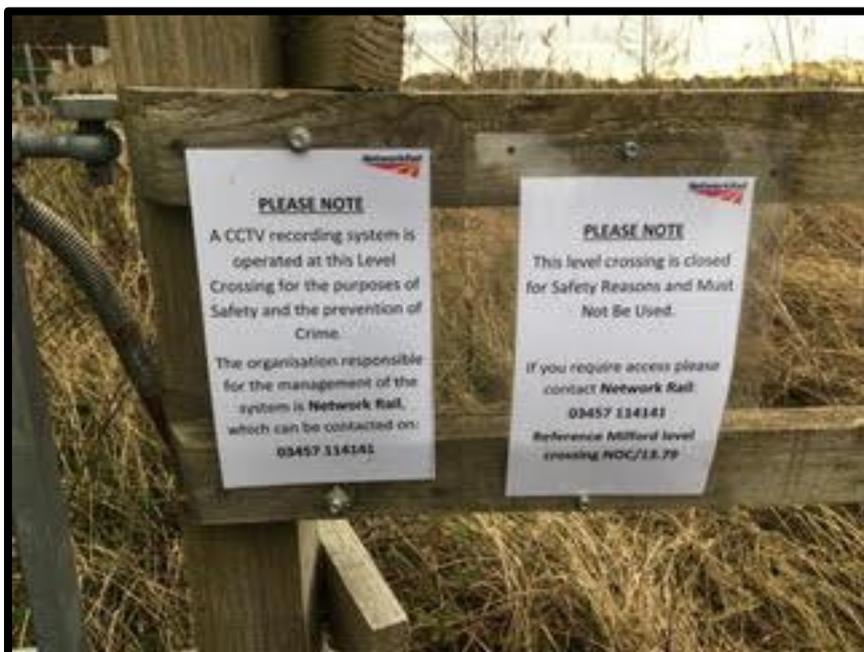
- Surveyed on 02/04/2020 by HGS and by LF.
- It is the surveyors' understanding that stabilisation works of the railway embankment have blocked the footpath for some years.
- The path was subject to a temporary emergency closure on 03/09/2020 by NYCC due to public safety pending closure of the railway crossing, in place until 22/03/2021.
- The photos show that the level crossing was closed at the time of the survey, which was before the temporary emergency closure.
- There is no signpost from Common Lane

Figure 32: Photo of path 35.59/5/1 – notices by railway crossing

- SMPC is aware that Network Rail intends to apply for this level crossing to be permanently closed, which would lead to the extinction of the path. The application process involves a public consultation with the community. Therefore, SMPC will await for more information from NYCC and Network Rail, and will put forward its views through the consultation.

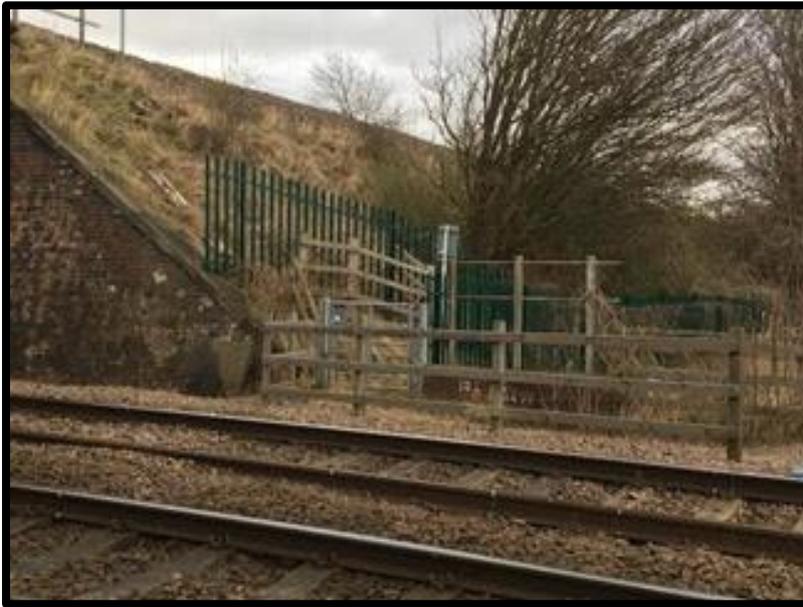
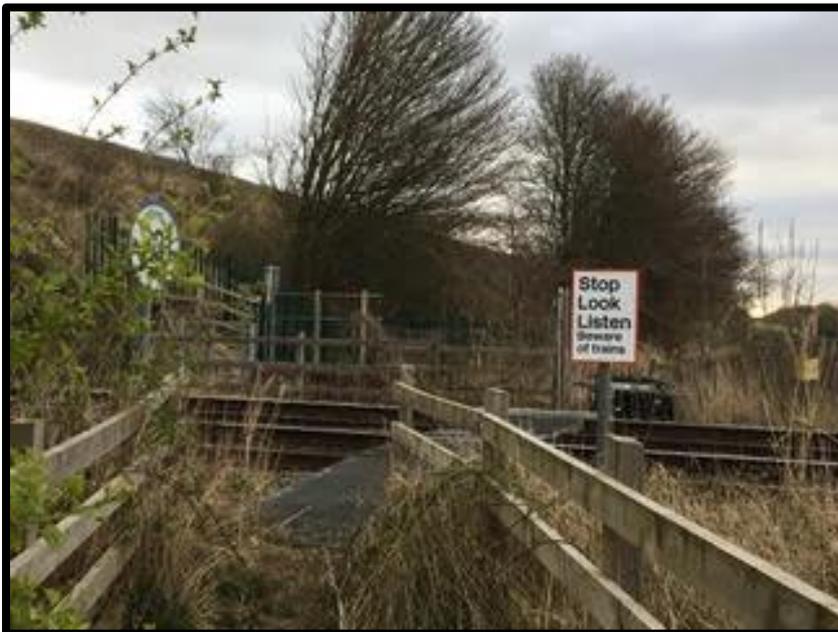
Figure 33: Photo of path 35.59/5/1 – railway crossing

Figure 34: Photo of path 35.59/5/1 – railway crossing

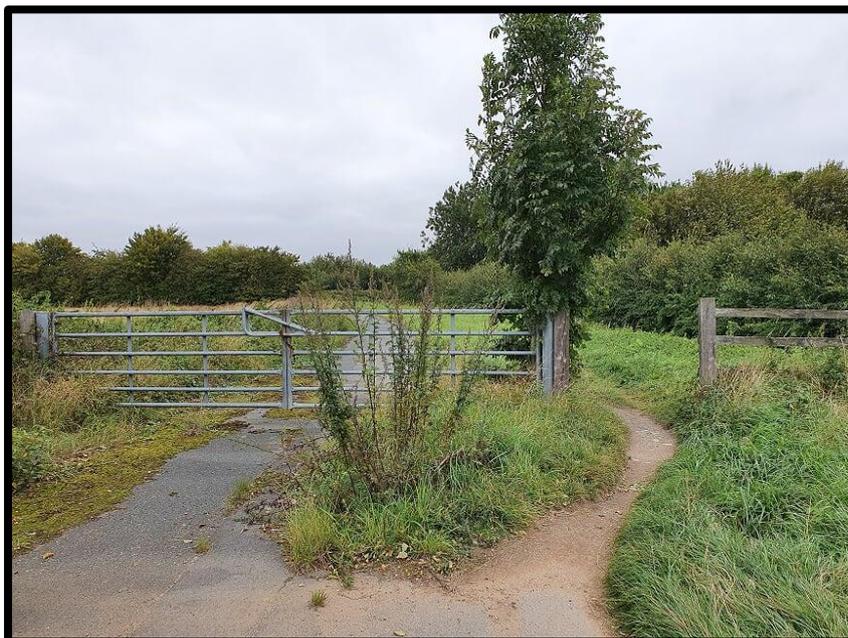
- Surveyed on 27/09/2020 by RdFD and IdFD.
- From the Common Lane end, there is no signpost although there is a gap in the fence.
- The surface is tarmac and is in fair condition. There is some rubbish on the hedgerows.
- At the A162 bypass, there is no signpost.

Figure 36: Photo of path 35.59/20/1 Common Lane end

- To install signposts at both ends.

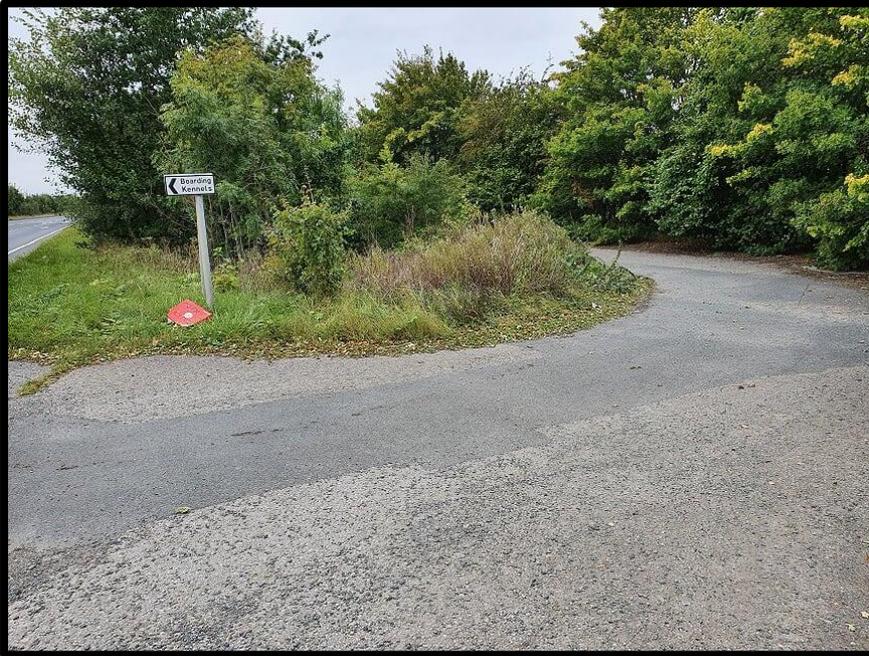
Figure 37: Photo of path 35.59/20/1 A162 bypass end

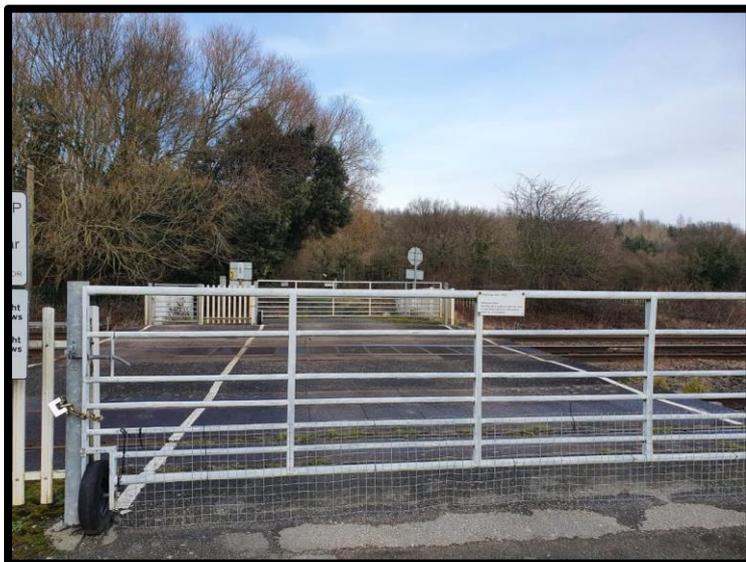
- Surveyed on 10/01/2021 by RdFD and IdFD.
- The path is in good condition, but it is not marked with signposts.
- The path has a footpath status in the definitive map; however the markings on the soil suggest that it is used by cyclists. Given its width and surface, it is not a problem for the path to be shared between walkers and cyclists.

Figure 42: Photo of path 35.59/16/1 showing that there is no signage

- To install signposts at both ends of the footpath.

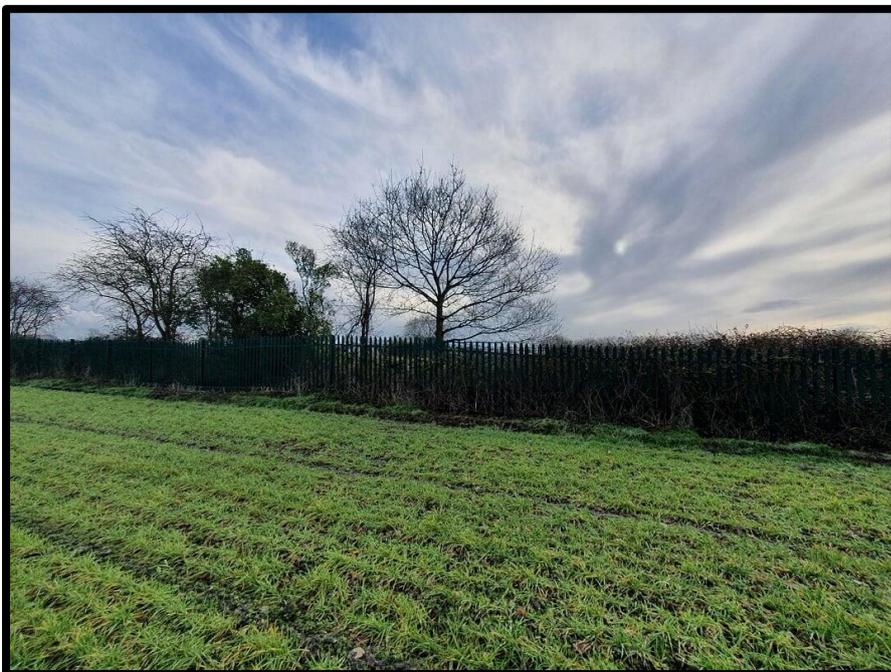
*Figure 46: Photo of path 35.59/2/3, showing that the railway line is fenced and there is no passage over the line*

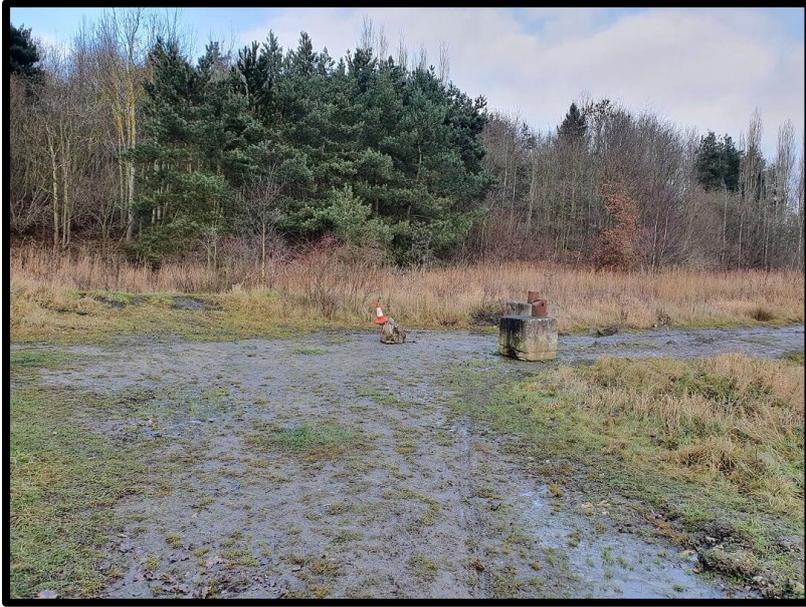
*Figure 48: Path 35.59/1/1 at its west end – no signpost*

- To install signposts.
- To prune overgrown vegetation at the north section.

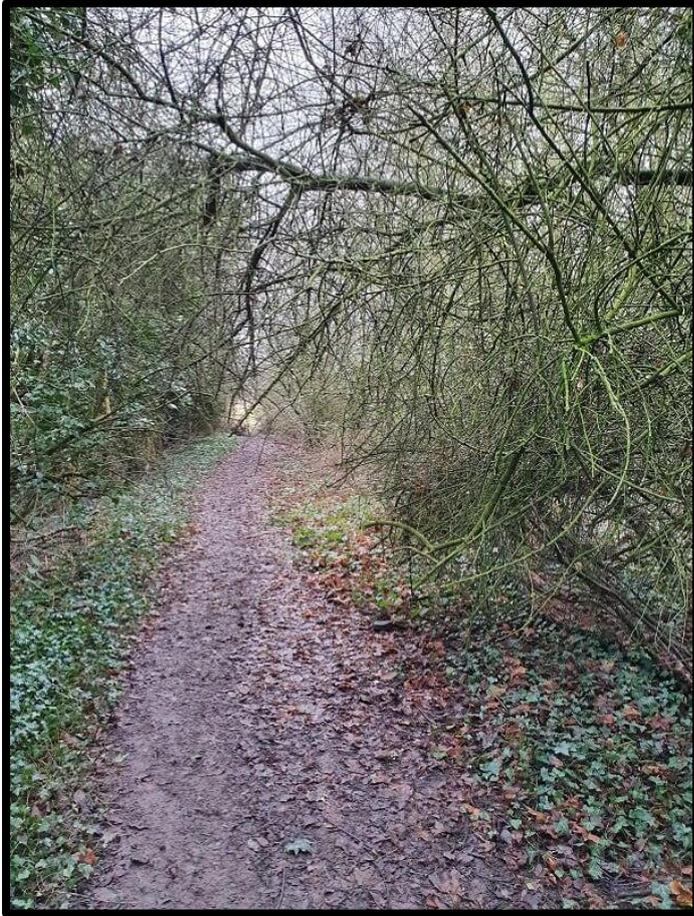
- Surveyed on 10/01/2021 by RdFD and IdFD.
- The footpath is in fair condition, although muddy at places. There is some overgrown vegetation on the north section, approaching Melton Leys.
- This footpath has no signposts at both ends.

*Figure 50: Path 35.59/1/1 at the north section – overgrown vegetation*

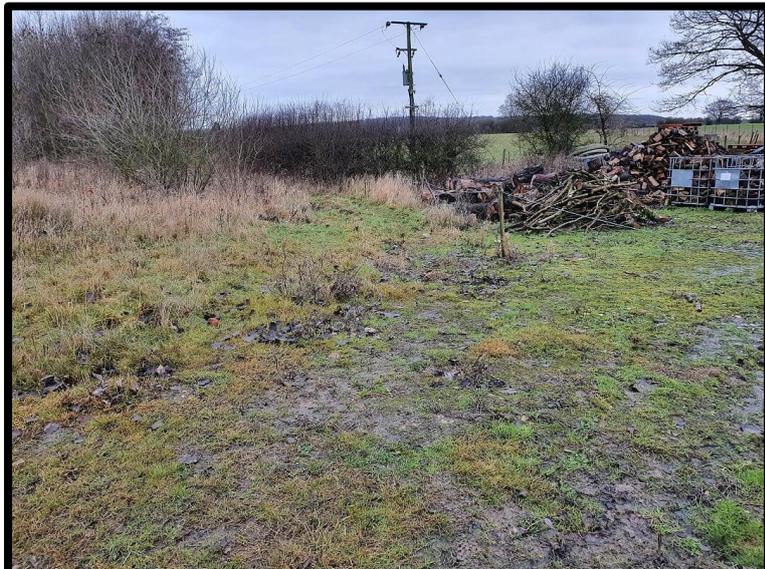
- Surveyed on 10/01/2021 by RdFD and IdFD.
- The footpath is in good condition, but there are no signposts.

Figure 52: Photo of path 35.58/15/1 north-east end – no signpost

- To install signposts.

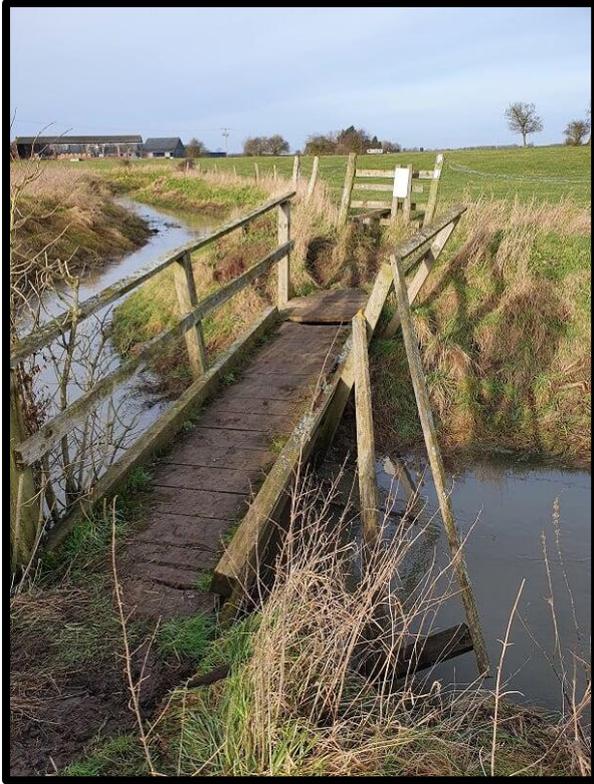
- Surveyed on 17/01/2021 by RdFD and IdFD.
- From the east, the path starts on a footbridge, that links to path 35.32/2/1 (Hambleton Parish). The footbridge is in poor condition, although it is passable. This has been reported to NYCC.
- There is no signage from the eastern end.
- The route from the field border to the west, until the point the path turns northwest to Melton Leys, is not signposted and the path route is not clear from the ground.
- There is a signpost with two arrows near the stream, which could lead walkers to interpret the route as being by the stream, which is incorrect.
- The link between this path and path 35.57/25/1 is blocked.
- Footprints at the western end, where the path runs close to path 35.59/1/1, suggests that walkers may have been walking across the gate to access path 35.59/1/1, which links to path 35.57/25/1.

Figure 54: Photo of 35.59/4/1, showing the footbridge in poor condition

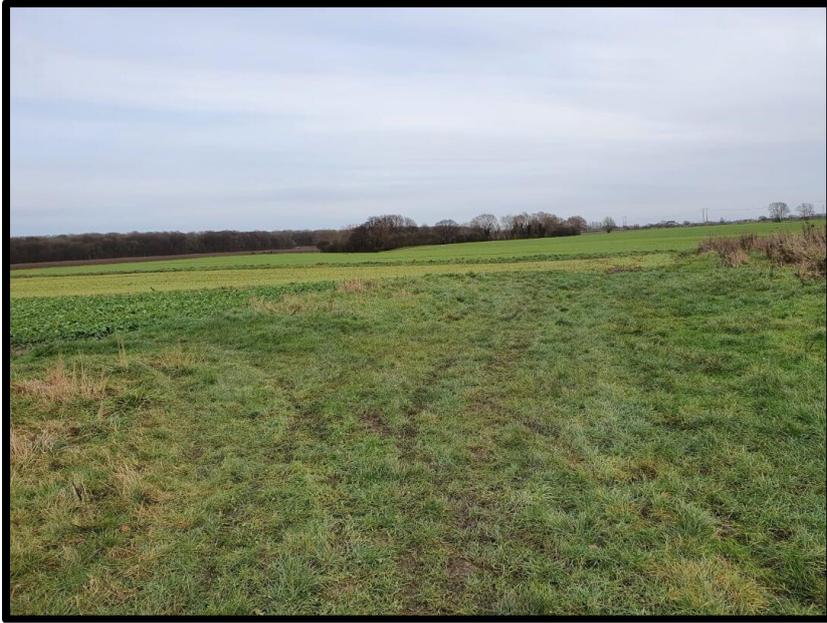
*Figure 56: Photo of 35.59/4/1, showing the lack of clear route over the field*

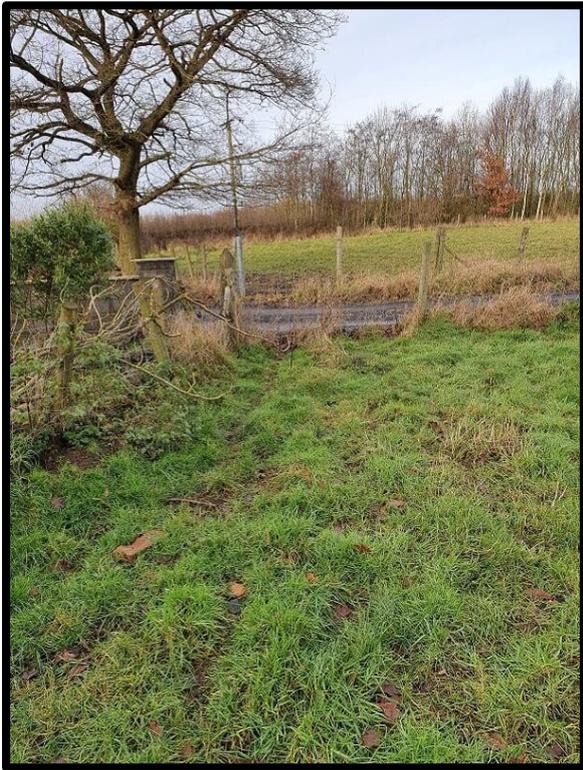
Figure 58: Photo of 35.59/4/1, showing that the link to path 35.57/25/1 was blocked

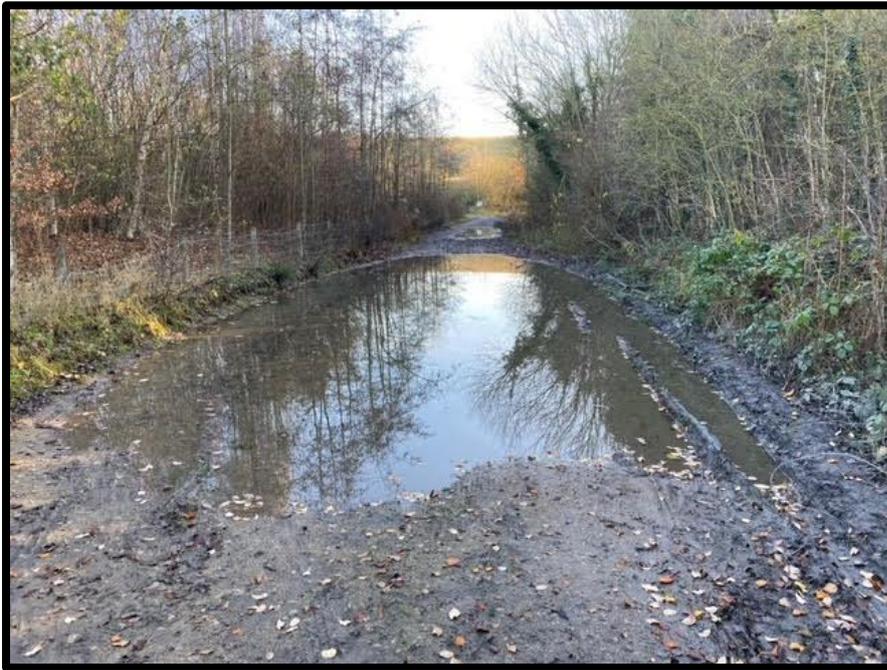
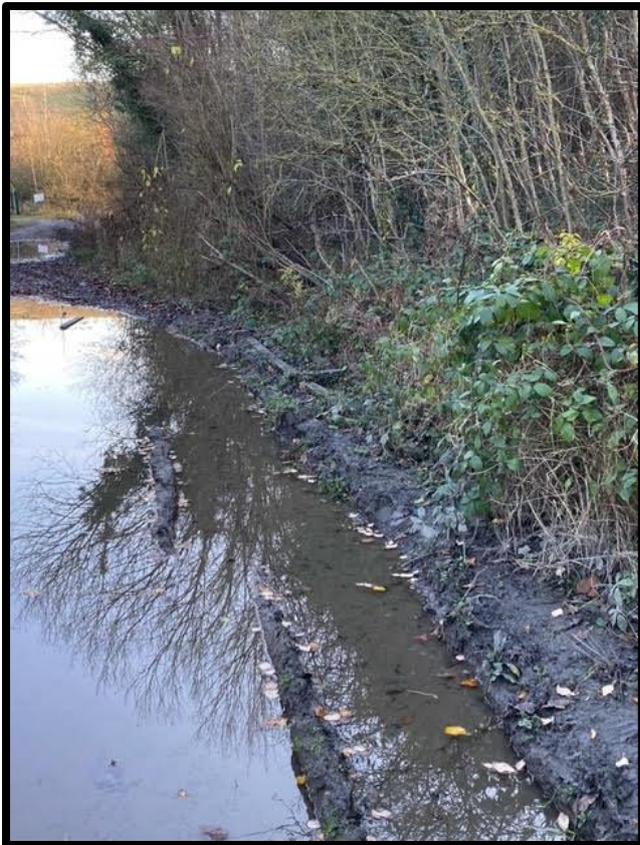
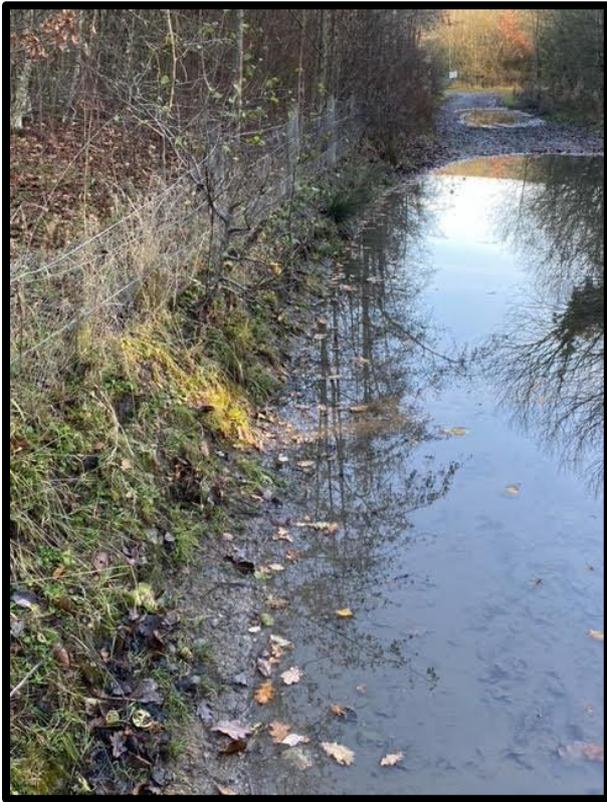
- Surveyed on 01/12/2020 by LF.
- The footpath is in poor condition, with large and deep craters full of water. At the time of the survey, it had not rained for 3-4 weeks, but the path remained waterlogged.
- There is no signage at either end of the footpath.
- There is a notice asking the public not to visit this location which are no longer in line with the COVID-19 regulations.

- To install signage to the footpath.
- To remove notices asking the asking the public not to visit this location.
- To improve the condition of the footpath.

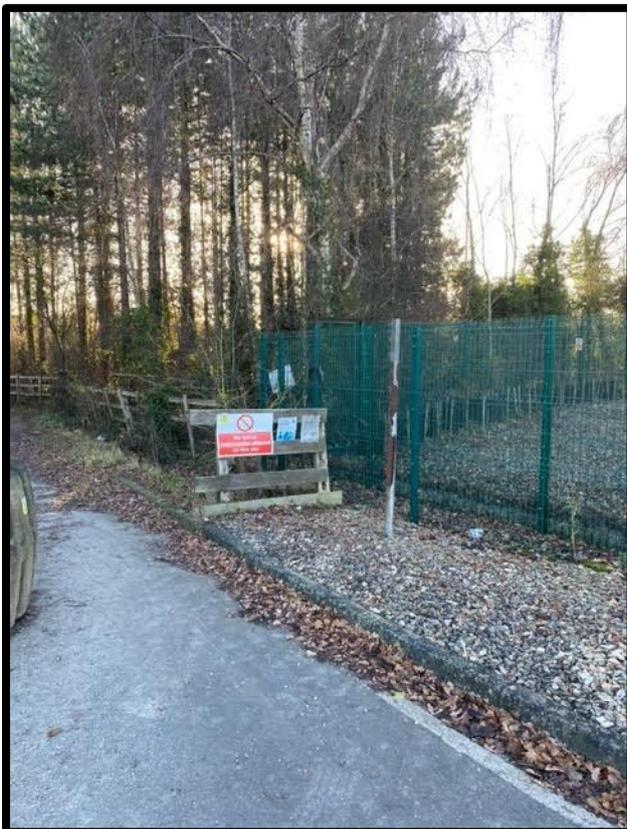
Figure 64: Photo of 35.59/2/1 Hagg Lane – police signage asking the public not to visit this location
