Survey  
of  
public rights of way (path)  
in  
South Milford Parish

Report to the South Milford Parish Council

Date: 16<sup>th</sup> February 2021

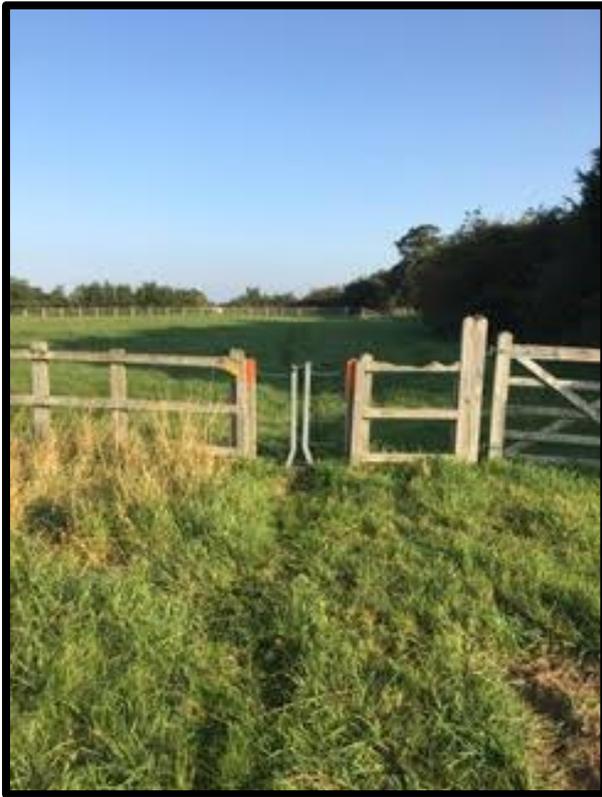
Figure 17: Photo of way through fence at point D of path 35.59/9/1

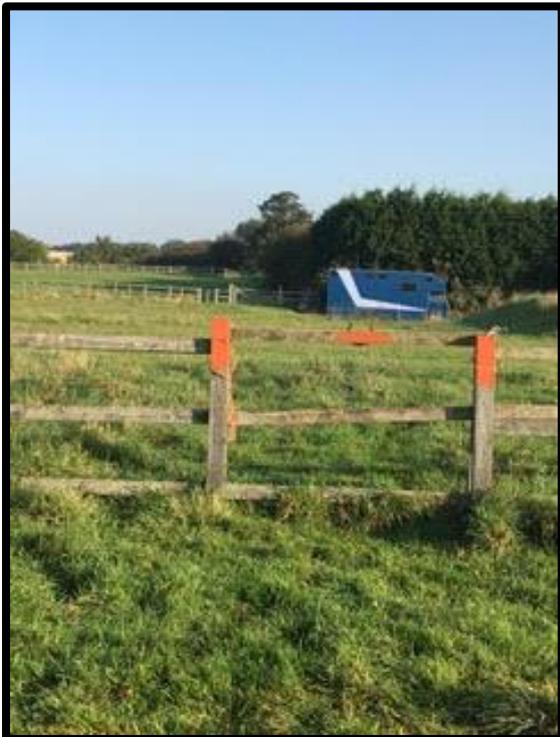
- It has old style Yorkshire C.C. signposts at either end where it joins the public highway Westfield Lane and at Whin Lane.
- Although not way marked as such, the landowners have assisted by clearly indicating the point where to pass through the hedges and fences with orange paint through the paddocks at Steeton Hall.
- Includes two 'chain gates' at points D and E of the map above and a gate which requires sliding the fence rails across at point C.

Figure 18: Photo of way through fence at point C of path 35.59/9/1

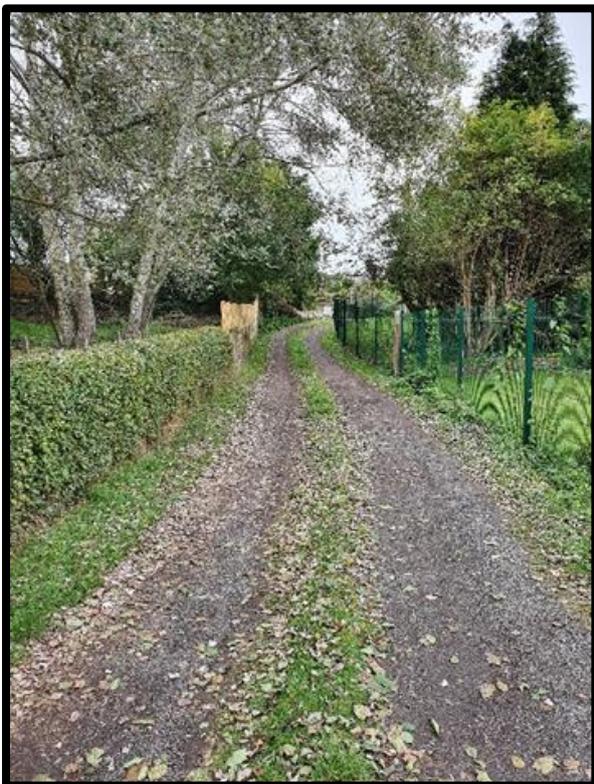
- There is a foot bridge across the stream – passable but handrails are in poor condition.
- According to the Definitive Map, the path crosses private dwellings, marked on the map as Mill Farm Nursery. Given that it is not possible to take the definitive line, I walked on what seems to be the private dwelling's driveway to Mill Lane (unimpeded).

Figure 28: Photo of 35.59/11/1 Driveway to Mill Lane

- Install signposts.
- To install traffic lights on the railway crossing, given that it is heavily used by young people to and from Sherburn High School.
- Confirm the path route by the former Mill Farm Nursery.
- Repair the handrails in footbridge.

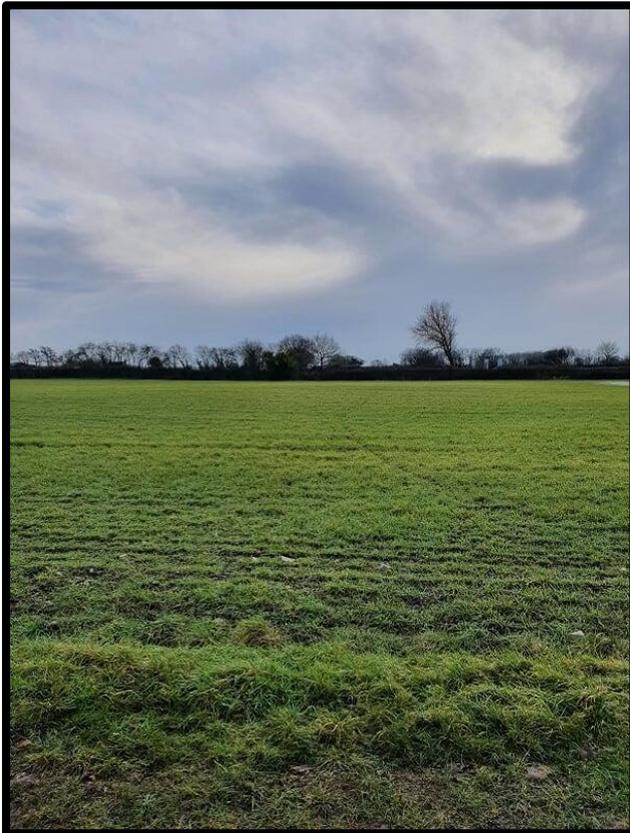
- Surveyed on 23/01/2021 by RdFD and IdFD.
- This path is not signposted at either end.
- There are some foot markings on the soil, suggesting that it is in use.
- The footpath is a cul-de-sac, as there is no railway crossing.
- According to older maps, this footpath used to link to the bridleway near Owlett Hall.

*Figure 45: Photo of path 35.59/2/3, showing foot markings over the field similar to the route taken by the path*

- To bring this path into use, it would be necessary to open the railway crossing and reactivate the historical link to the bridleway to the west of Owlett Hall and install signage.
- An alternative to creating a new railway crossing is to establish a new link between Common Lane and the bridleway to the west of Owlett Hall, and to extinguish this path.

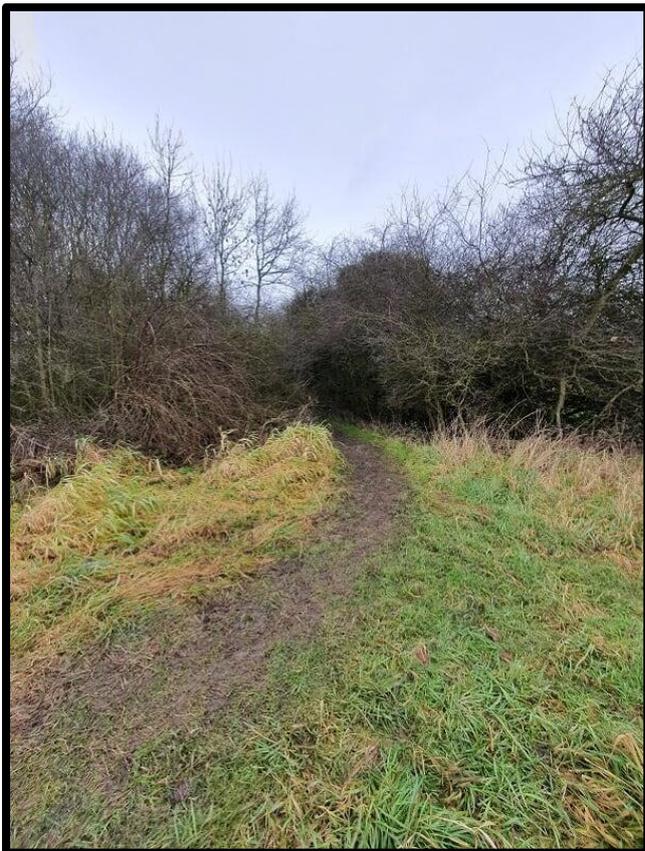
- Surveyed on 10/01/2021 by RdFD and IdFD.
- The footpath is in fair condition, although muddy at places. There is some overgrown vegetation on the north section, approaching Melton Leys.
- This footpath has no signposts at both ends.

*Figure 49: Path 35.59/1/1 at the beginning of the north section*

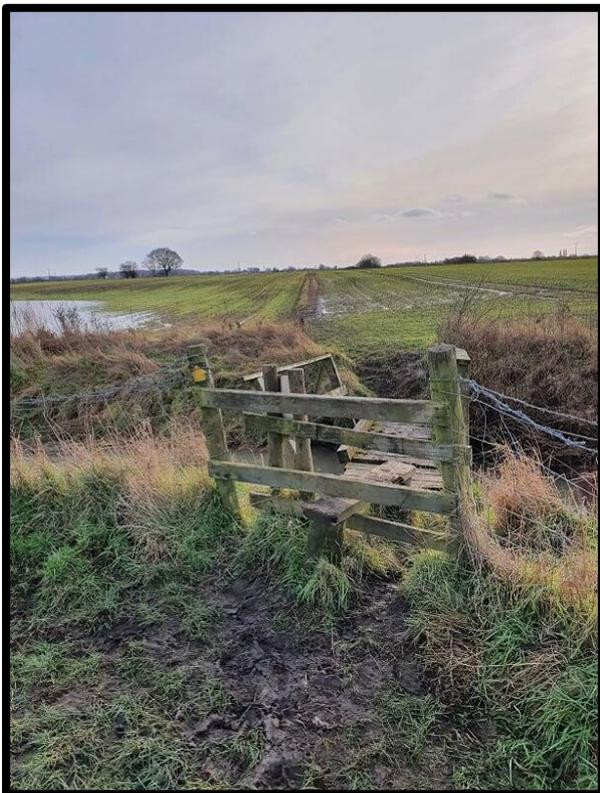
Figure 55: Photo of 35.59/4/1, showing the small yellow sign marking the path

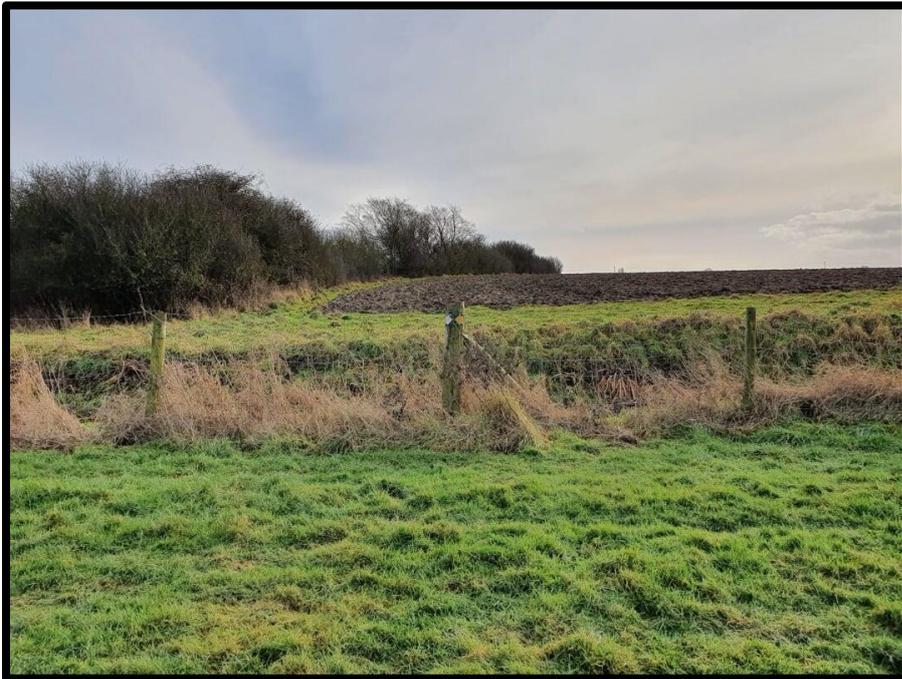
*Figure 57: Photo of 35.59/4/1, showing a sign with arrows near the stream*

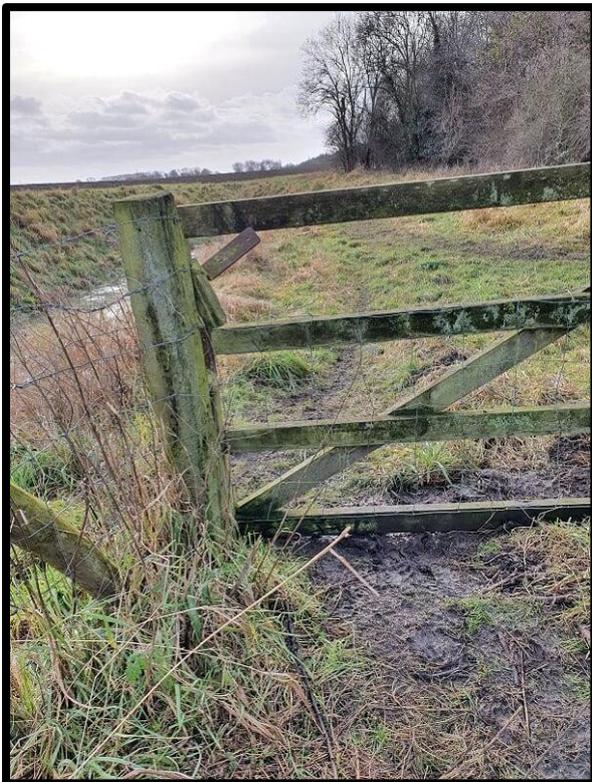
- Surveyed on 17/01/2021 by RdFD and IdFD.
- From the east, the path starts on a footbridge, that links to path 35.32/2/1 (Hambleton Parish). The footbridge is in poor condition, although it is passable. This has been reported to NYCC.
- There is no signage from the eastern end.
- The route from the field border to the west, until the point the path turns northwest to Melton Leys, is not signposted and the path route is not clear from the ground.
- There is a signpost with two arrows near the stream, which could lead walkers to interpret the route as being by the stream, which is incorrect.
- The link between this path and path 35.57/25/1 is blocked.
- Footprints at the western end, where the path runs close to path 35.59/1/1, suggests that walkers may have been walking across the gate to access path 35.59/1/1, which links to path 35.57/25/1.

Figure 59: Photo of 35.59/4/1, suggesting that walkers may be crossing the gate to path 35.59/1/1
